Defending against Corrosion

A Livermore-designed engineered barrier system for the proposed Yucca Mountain nuclear waste repository works with natural barriers to keep radioactive waste in its place.

Lawrence Livermore National Laboratory

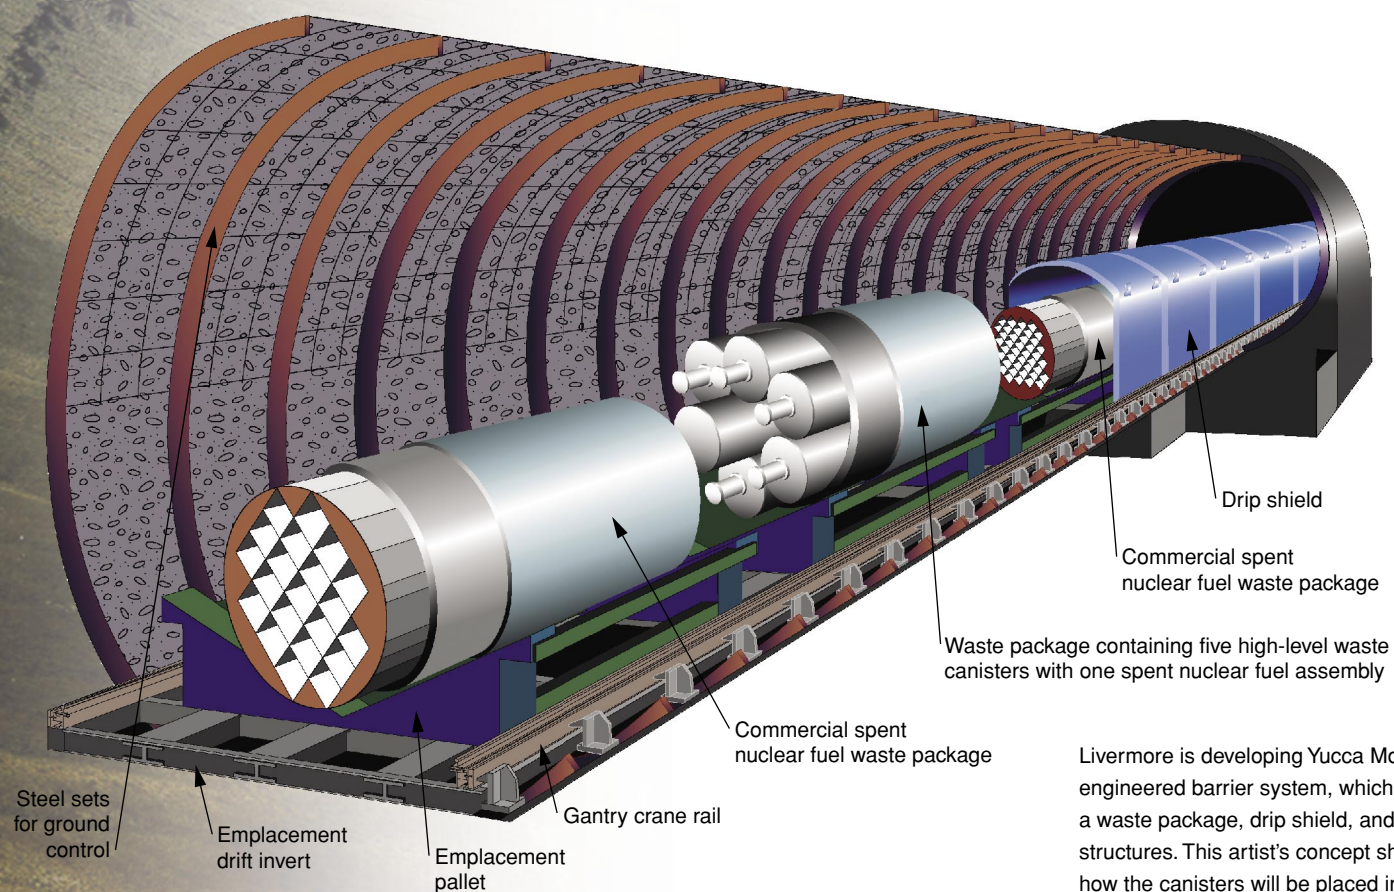
Livermore is developing Yucca Mountain's engineered barrier system, which consists of a waste package, drip shield, and supporting structures. This artist's concept shows how the canisters will be placed in tunnels about 300 meters underground. The waste packages will rest on a strong corrosion-resistant pallet and supporting steel frame.

The current repository design calls for waste to be stored in a package consisting of a set of two nested canisters—an outer canister made of a highly corrosion-resistant metal (Alloy 22) and an inner canister made of a tough, nuclear-grade stainless steel (316NG). An overhanging drip shield made of titanium will provide additional protection to the waste package from dripping water and any falling rocks from the repository ceiling. “Because the waste package and the drip shield are made of different corrosion-resistant materials, they form corrosion defense in depth,” says McCright.

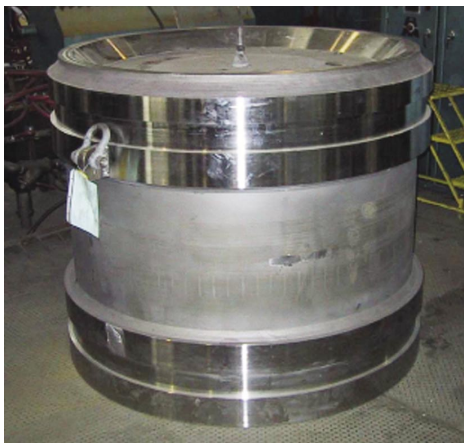
Livermore scientists are testing the design of the waste packages to be used in the Yucca Mountain repository. The waste packages will have a common diameter (1.8 meters), but their lengths will vary according to the type of waste—from about 3.6 meters for defense waste to 5.7 meters for spent nuclear fuel. The scientists work on prototypes like the one above that have the full-scale diameter but shortened lengths.

waste packages will create a relatively uniform temperature in each underground drift, or tunnel, carved inside the mountain. The waste packages have a common diameter (1.8 meters), but their lengths vary according to the type of waste—from about 3.6 meters for the defense waste to 5.7 meters for the spent nuclear fuel.

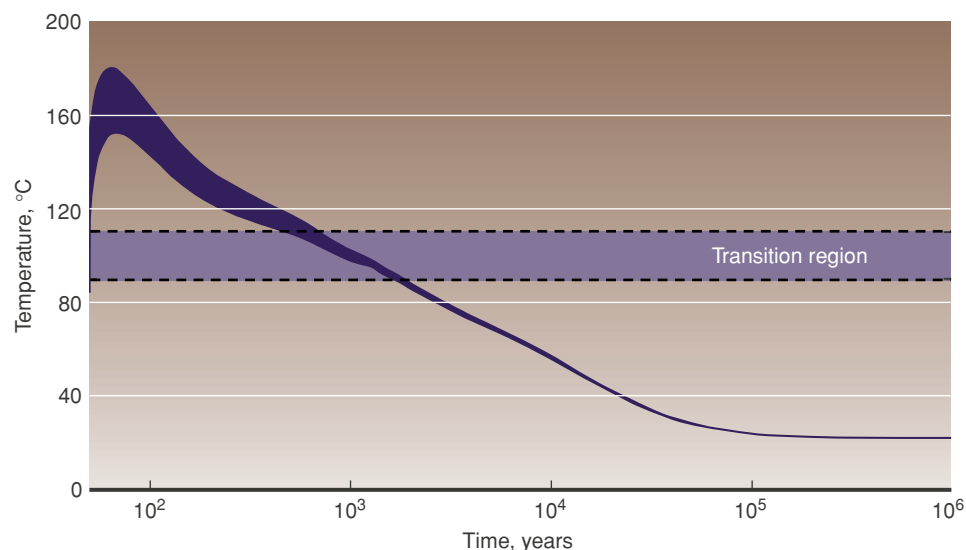
Once the repository is sealed, it will take hundreds of years before waste-package surface temperatures drop below boiling because of the slow decay of the radioactive waste. This graph shows the projected decline of temperatures on waste canisters’ surfaces over 1 million years. The range of temperatures corresponds to uncertainty about heat-transfer modes, variation among the heat output of individual waste packages, and the location of waste packages in the repository. The dotted transition region marks where temperatures fall below boiling. At this point, water may come into contact with the containers.

The pallet, in turn, will sit on a steel frame and crushed gravel. The waste packages will be placed close together (about a meter apart) so that by design their surfaces will reach a maximum surface temperature of 160°C (caused by radiation levels of up to 180 rads per hour) once the repository is sealed. "It may take hundreds of years before surface temperatures cool below boiling because of the slow decay of radioactive components in the waste," says McCright. Keeping the canister surfaces above the boiling point will ensure they are dry, with the intention to prevent corrosion.

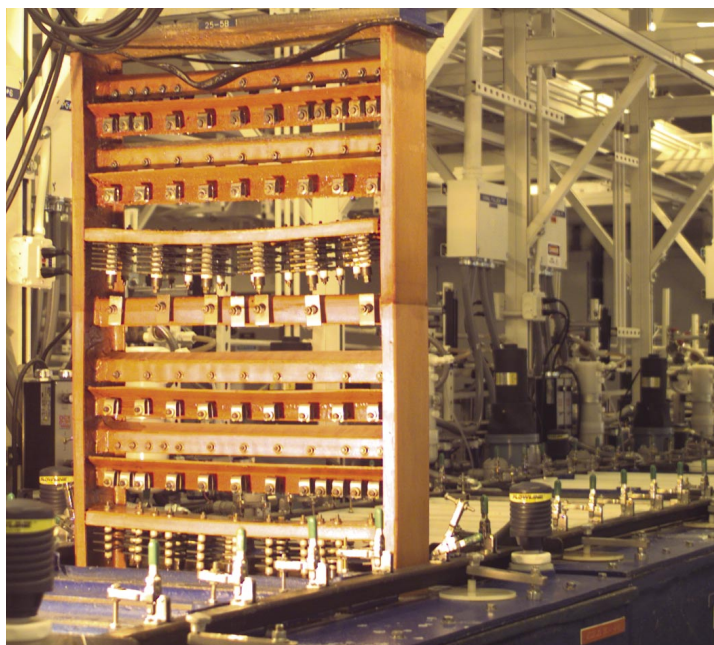
Corrosion tests of metal samples, called coupons, are carried out at Livermore's Long-Term Corrosion Test Facility. Four types of coupons are kept in 24 tanks, each filled with about 1,000 liters of one of the three aqueous solutions that are likely to be found in the underground Yucca Mountain environment. In this photograph, a rack containing several hundred coupons is pulled out of solution for inspection.

The coupons are kept in 24 tanks, each filled with about 1,000 liters of one of three different solutions derived from those likely to be found in the Yucca Mountain environment. One solution is a concentrated mixture of salts and minerals common to Yucca Mountain. The second solution is a diluted version of this mixture. The third

solution is an acidified version of the concentrated mixture. Solutions are heated to either 60°C or 90°C. The coupons are mounted on vertical racks and are either submerged in solution, suspended over the solution, or partially submerged.

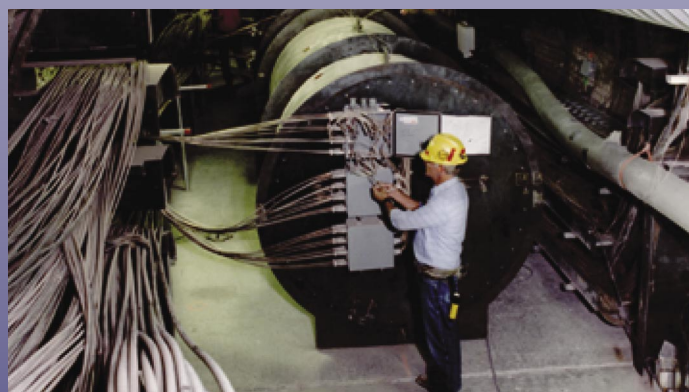
Scientists at Yucca Mountain's Drift Scale Test Facility are acquiring a better understanding of the thermal, mechanical, hydrological, and chemical processes that occur deep underground at the site.

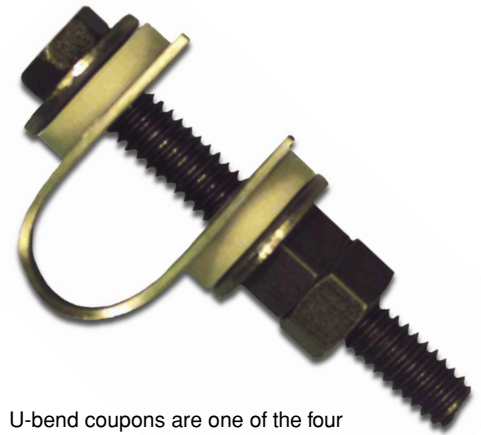
U-bend coupons are one of the four types of coupons being tested for corrosion resistance. U-bends are metals kept under continuous stress to try to induce stress corrosion cracking.

Four kinds of coupons are used to test the various forms of corrosion. Crevice coupons consist of metals tightly pressed against Teflon washers to determine the extent of corrosion from liquid trapped between the metal and washer. Weight-loss coupons measure general corrosion. Galvanic coupons measure corrosion that occurs when two dissimilar alloys are pressed against each other. Finally, U-bend coupons are metals bent under continuous stress to try to induce stress corrosion cracking. Many of the coupons are welded to determine the effects, if any, of welds on corrosion.

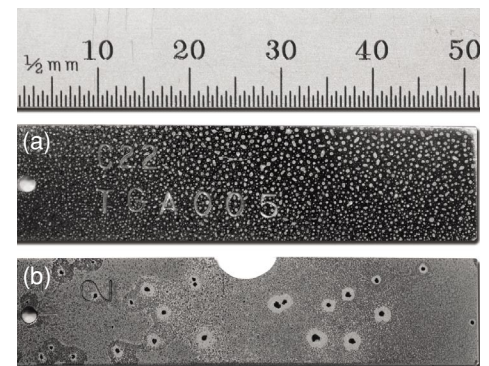
Coupons of (a) Alloy 22 and (b) Alloy 825 (which contains less nickel and molybdenum than Alloy 22) show many precipitates when subjected to high concentrations of minerals and salts. However, Alloy 22 has no localized corrosion whereas Alloy 825 has permanent pits caused by corrosion.

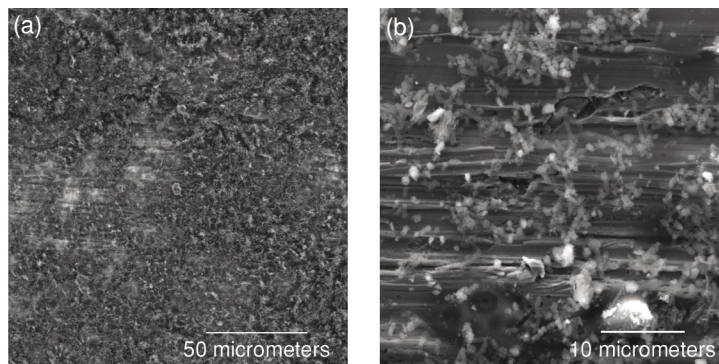
Thin films of bacteria form on the surface of metal coupons tested in a solution containing nonsterile crushed Yucca Mountain rock. Bacteria that have colonized on an Alloy 22 coupon are shown magnified (a) 1,200 times and (b) 5,000 times.

Horn's team has identified more than 65 species and subspecies of bacteria living in the Yucca Mountain rock. The team has also identified the different growth requirements for these bacteria. One set of laboratory experiments analyzes the extent of corrosion on metal coupons caused by bacteria contained in crushed Yucca Mountain rock and fed with simulated groundwater. Another set of experiments determines the extent of corrosion caused by specific species of bacteria that have potentially corrosive activities, such as a species that oxidizes sulfur compounds. The results of these experiments are compared with the corrosion that occurs under identical conditions but in environments that have been presterilized to kill all microbes. The team also analyzes the solutions to determine if bacterial metabolic products could change the repository chemistry.

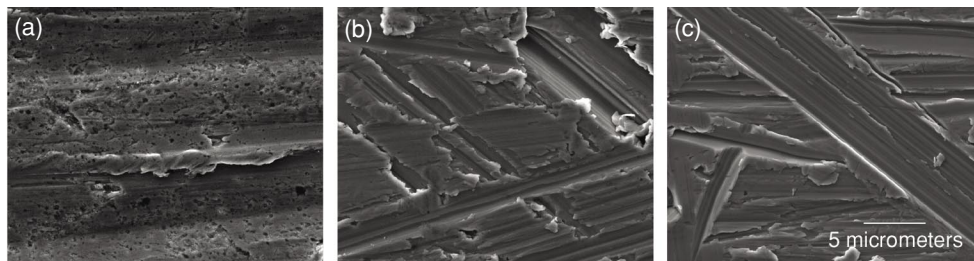
Electron micrographs (8,000 times magnification) show the extremely limited corrosion on an Alloy 22 coupon caused by bacteria after (a) 57 months in a solution containing nonsterile crushed Yucca Mountain rock compared to (b) a coupon that has been in a solution with presterilized rock (to kill all microbes) for 43 months, and (c) the same coupon at the start of the experiment.

"The findings of the bacterial experiments parallel those of the long-term corrosion facility," says Horn. "To date, our results show that over 10,000 years, the corrosion rate from bacteria would not penetrate beyond 1 millimeter. Alloy 22 is a very tough metal."
